FINAL REPORT, FISCAL YEAR 1982 COASTAL MANAGEMENT PROJECT
SUBGRANT LRP-431

PHASE II PRESERVATION AND REHABILITATION MT. BALDHEAD/OVAL BEACH RECREATION AREA (ENGINEERING, DESIGN AND CONSTRUCTION)

# 1982 MT. BALDHEAD/OVAL BEACH FEDERAL COASTAL ZONE MANAGEMENT PROJECT

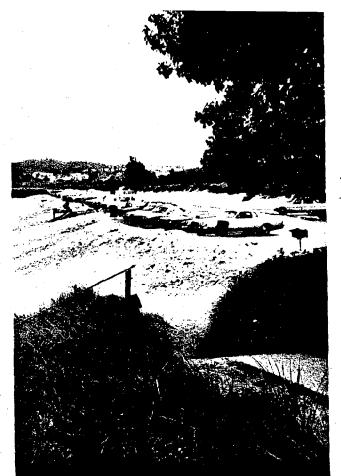
Before

Future Site of
Elevated Stringry
(Photo taken
toward Parking Lot)

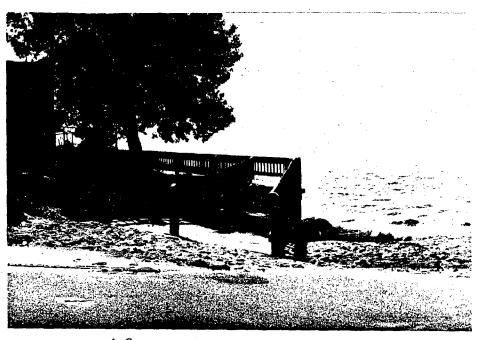
After Elevated Stairway (Photo taken from Parking Lot)

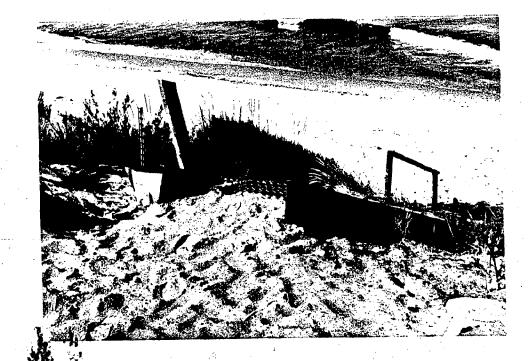
Before
Old damaged metal
Stairway ->

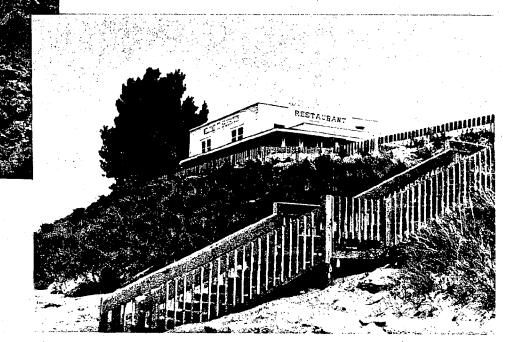
After New wooden stairway

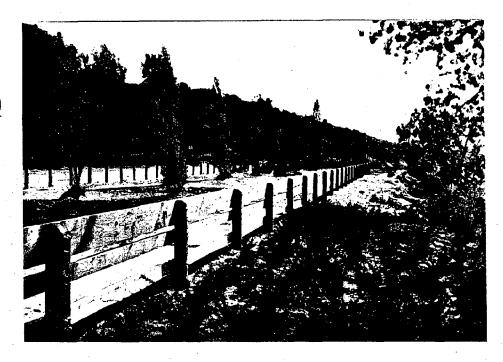
After Cleared & Straightened "Old Road" with handrail + plantings.

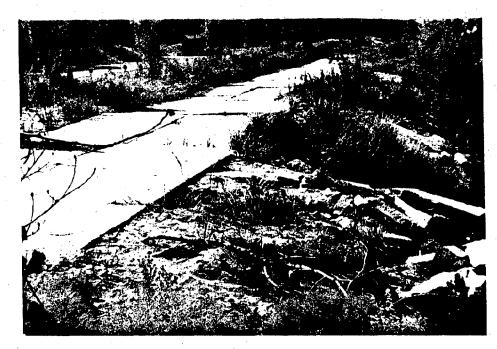
Before
"Old Road", cracked, damaged, and
badly eroded underneath.

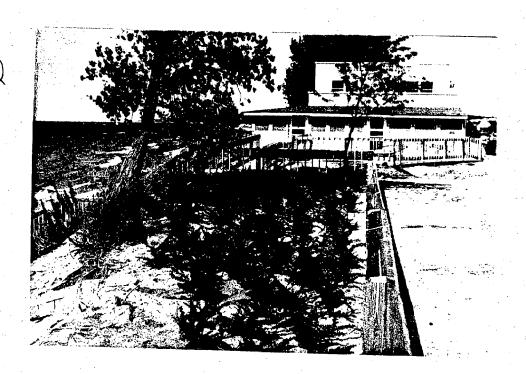
# After

Plantings and Wood walk way unning around beachhouse.

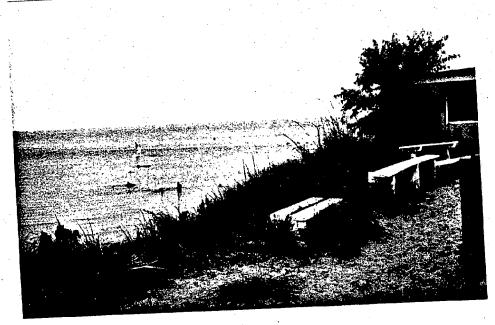
Before Back of Beach house.

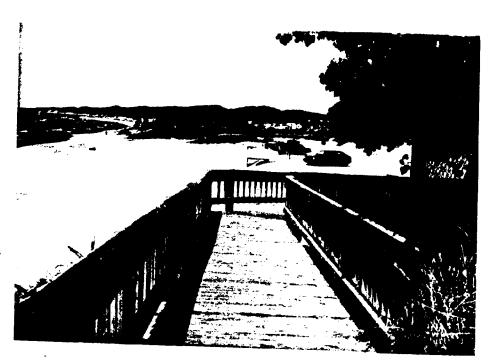
After

Dood walkway

From North

Farking Lot.

Behind Beach

Louse, to South

Beach area and

Stains

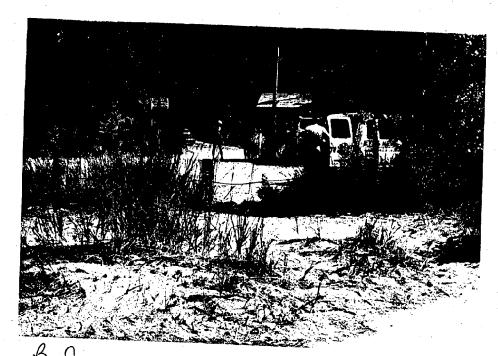
Botove
Overgrown area at South beach by
Entrance gate.

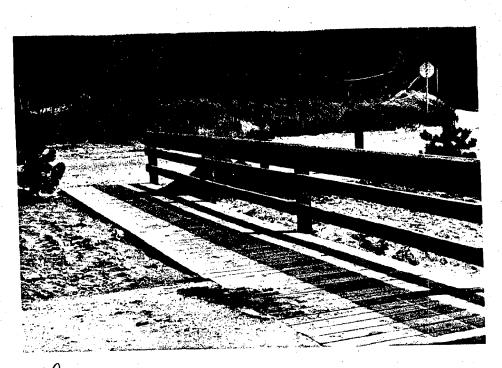
After
Wood walkway with handrail at South Beach
by entrance, gate. Leads to South Stairs and
by entrance, gate. Leads

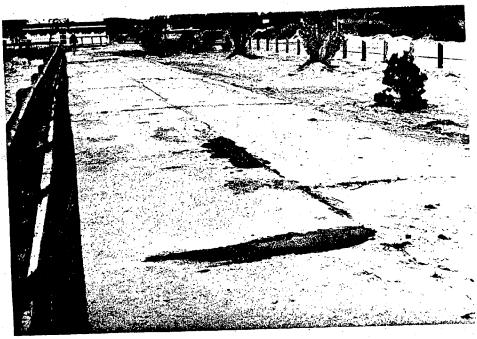
After

Jld road"—

Staightened and

epaired with

epaired, and

andrail.

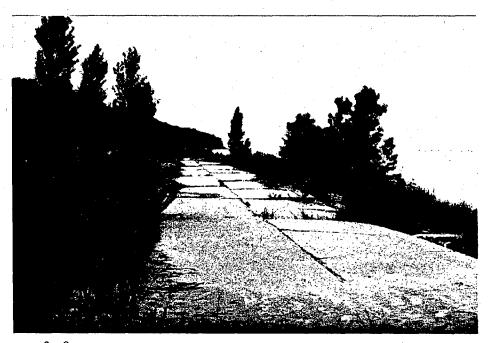
Besore
Old Road - overgrown, cracked, un even, and
dangerous.
